FIELD OBSERVATION REPORT

Emergency Structural Assessment of Earthquake

PROJECT: Damage to Kailua - Kona Wharf @ Kailua - Kona, HI JOB NO.: _____

PROJECT: Emergency Structural Assessment of Earthquake
Damage @ Kawaihae Small Boat Harbor JOB NO.: _____

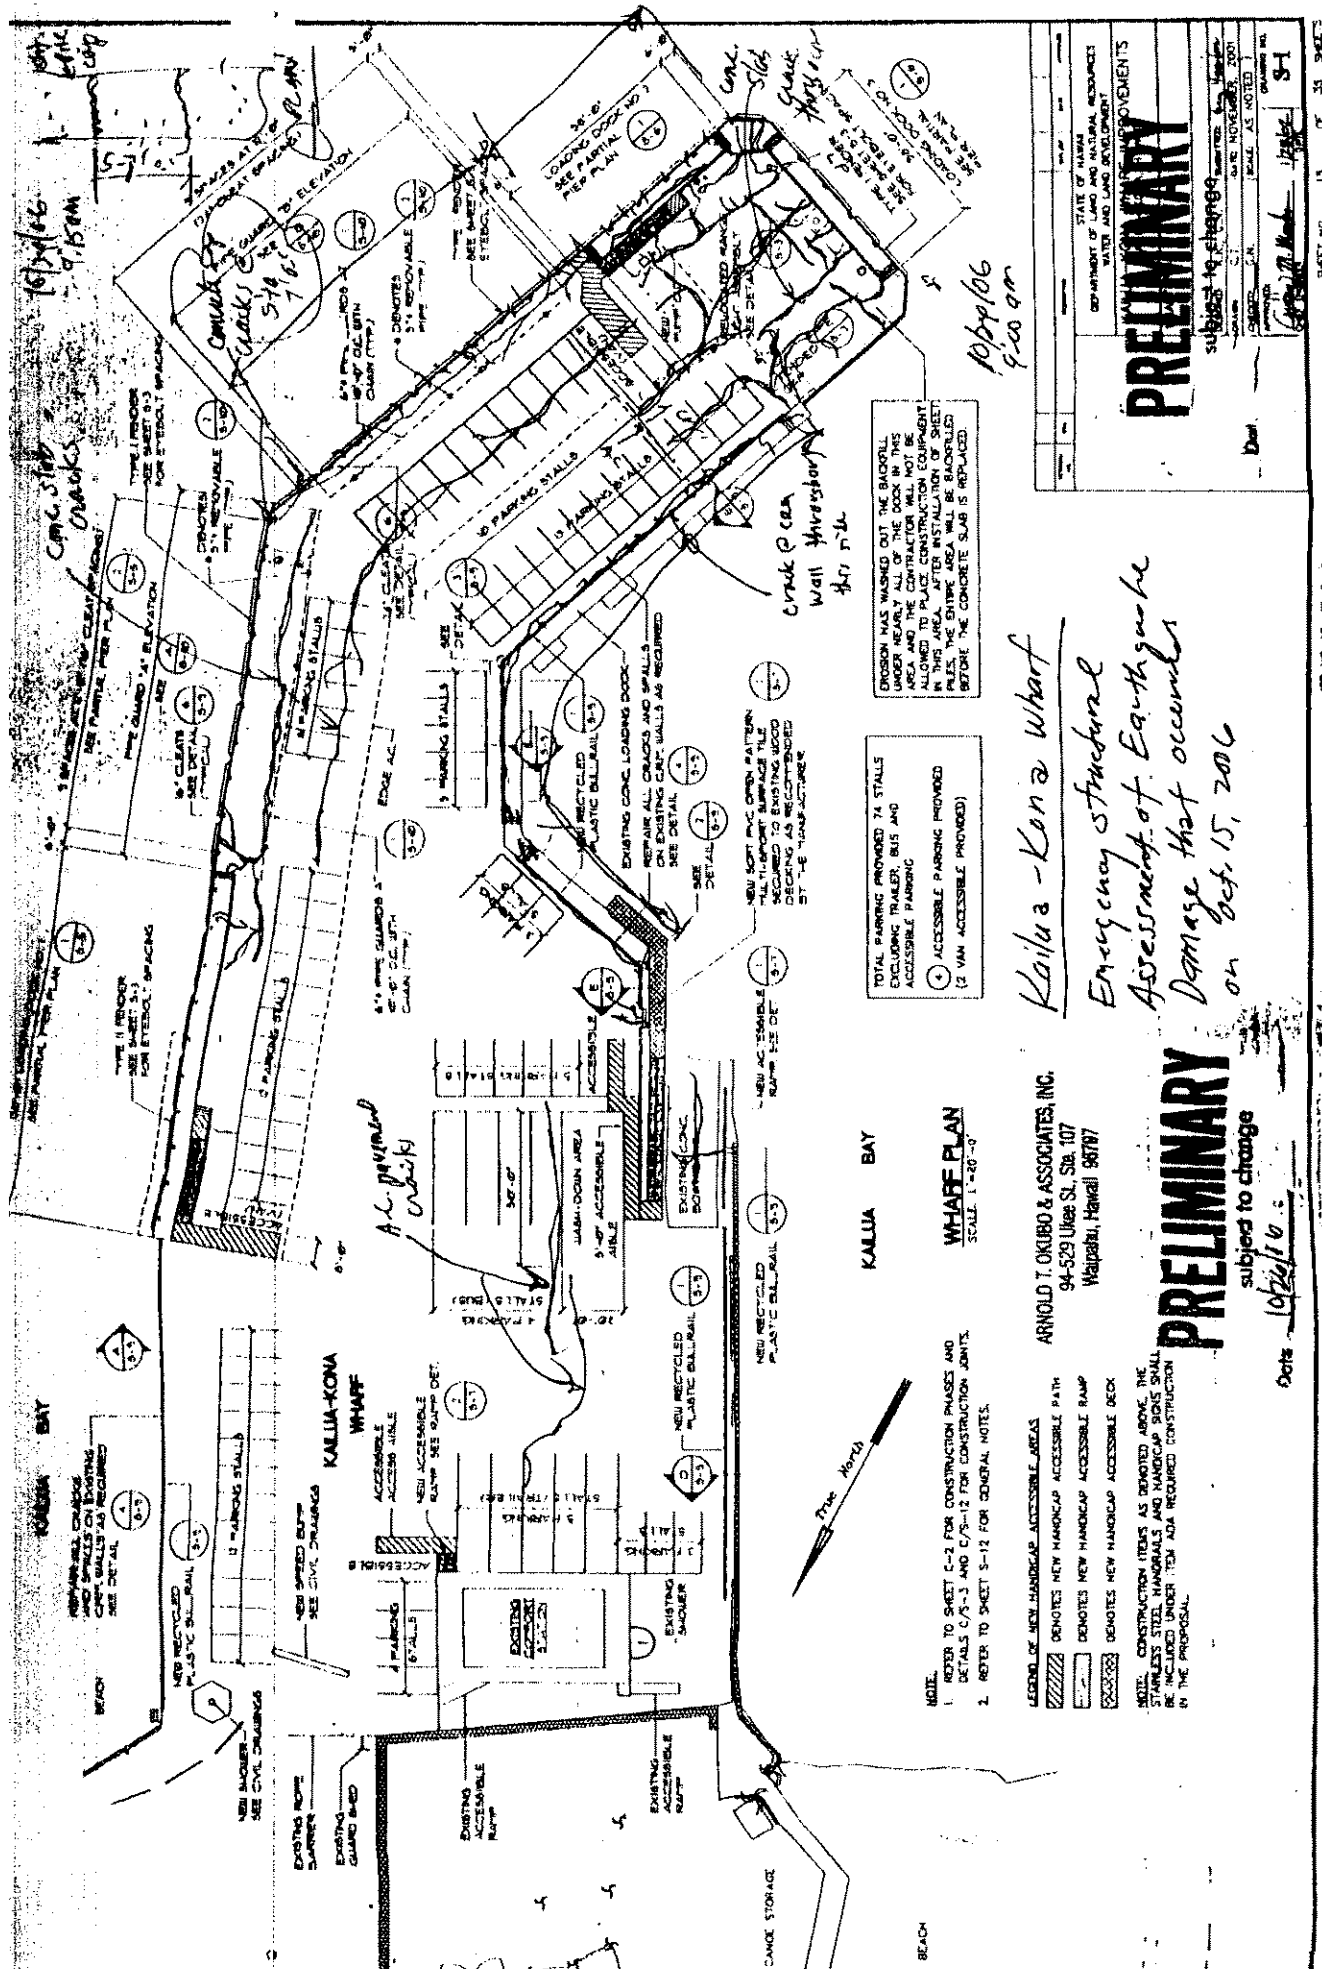
Kailua-Kona Wharf

Above Water Inspection: There many cracks caused by the earthquake throughout the wharf decks concrete slab, pile caps, stairways, walls, boat ramps, and A.C. pavements. The crack's width varies up to 1/8" in width. Cracks will need to be repaired to prevent future corrosion of the reinforcing bars and sheet pile bulkhead, also differential settlement, trip hazard, and future deterioration of the structure.

Underwater Inspection: Steel sheet pile bulkhead in good condition along the length of the wharf where a new sheet pile bulkhead was installed about 2 years ago. There are vertical cracks at the concrete cap that protects the steel sheet pile from corrosion. Cracks at pile caps are at numerous locations. Some surface rust scales that develop on the sheet pile surface had separated/delaminated from the surface of the sheet pile probably due to the bending and movement of the sheet pile during the earthquake.

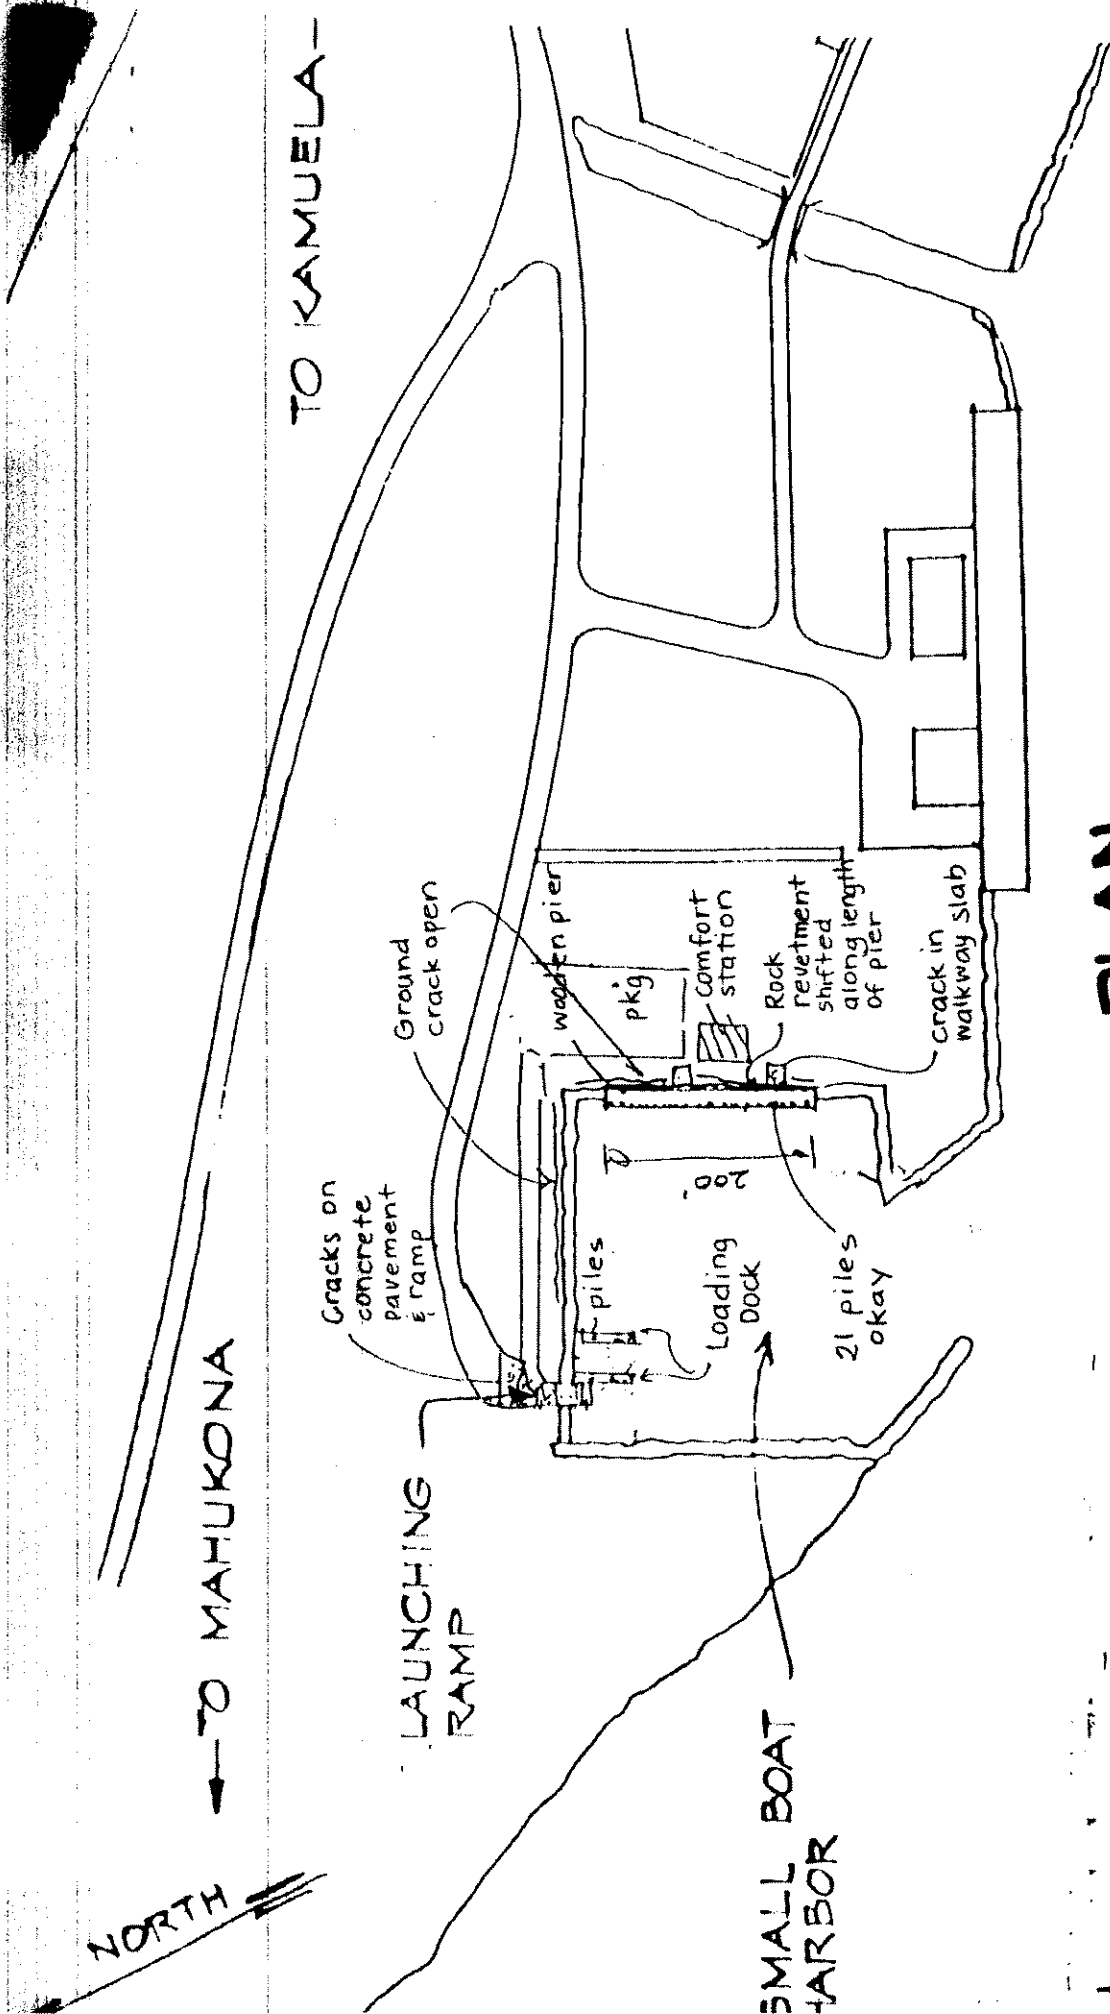
PLAN
NO SCALE

Above Water Inspection: Wooden pier deck already off limits due to previous damage from wave damage. The writer had inspected the wooded pier previously on March 2, 2006 and the wooden pier deck structural condition has not change due to the earthquake. The landside concrete slab walkway have cracks caused by the earthquake. The rock revetment slope protection has shifted along the wooden pier. The grounds at the pier has moved a few inches and created a crack in the ground.

Boat Ramps & Pavement: There are several cracks thru out caused by the earthquake.

Underwater Inspection: The existing 10"Ø steel pipe piles are in fair condition with no damage from the earthquake. The loading dock piles are in fair condition with no damage.
